SB-10056901-7043**FORD:**

2011-2015 Explorer

This article supersedes TSB 12-12-4 to update the vehicle model years and Service Procedure.

ISSUE

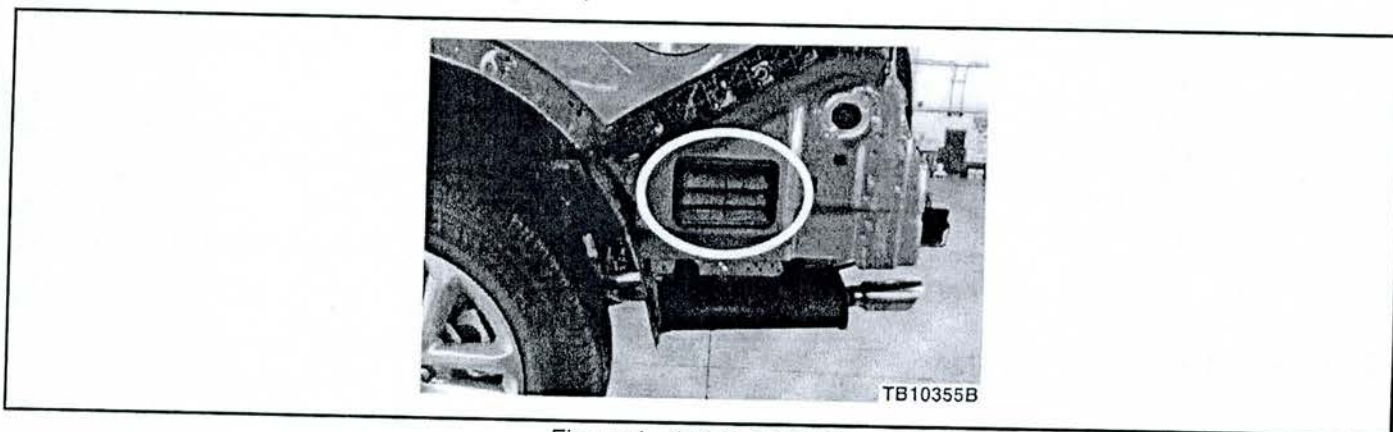
Figure 1 - Article 14-0130

Some 2011-2015 Explorer vehicles may exhibit an exhaust odor in the vehicle with the auxiliary climate control system on. Customers may indicate the odor smells like sulfur.

1. Reprogram the Heating Ventilation Air Conditioning (HVAC) module to the latest calibration using IDS release 91.02 or higher. Calibration files may also be obtained at www.motorcraftservice.com.
 - a. When reprogramming the HVAC, IDS will have additional questions that require a yes response to reprogram the module.
2. Remove the rear bumper cover. Refer to Workshop Manual (WSM), Section 501-19.
3. Replace the left side rear air extractor. (Figure 1)
